Re: Port Authority of Allegheny County
East Busway Rock Slope Stabilization Study
Geotechnical Engineering Report

This report summarizes the geotechnical investigation, findings, and preliminary recommendations for mitigation of the rock slopes located adjacent to the Martin Luther King East Busway (Busway) between Pitt Tower and 26th Street access ramp (Busway Stations 218+00 to 247+50).

ATTACHMENT 1
FIELD RECONNAISSANCE PLANS AND PHOTOGRAPHS

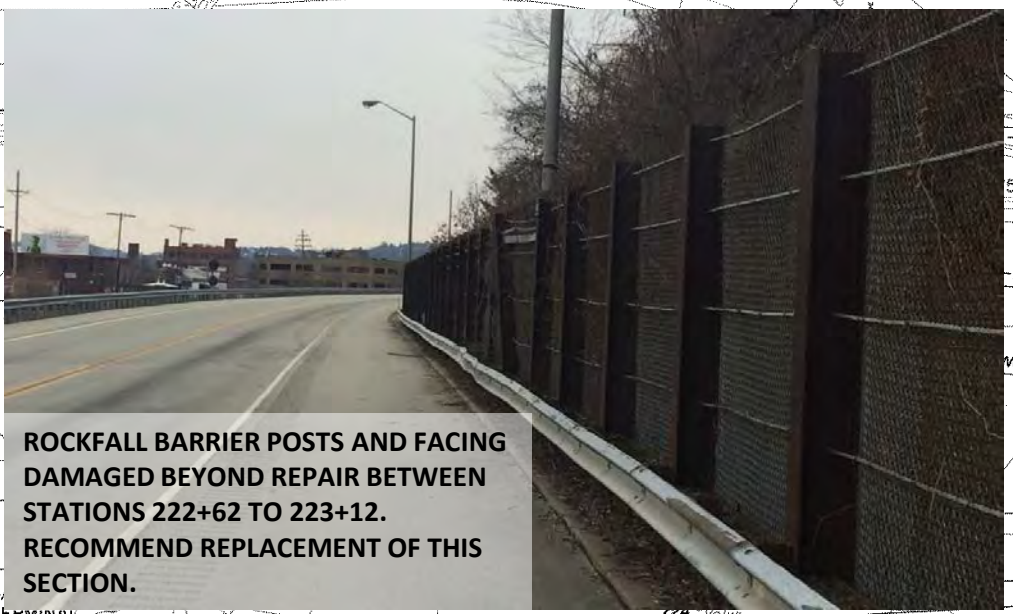
- The rockfall barrier between Stations 221+25 and 225+00 is still functioning to contain debris, with the exception of a 50 foot section between Stations 222+62 and 223+12. This posts and barrier facing in this area have been impacted by rockfall debris, damaging the posts and barrier beyond repair. The rockfall debris behind this entire barrier should be removed and the 50' section of barrier noted should be replaced to provide for additional rockfall to be contained in the area behind the barrier.

ROCKFALL BARRIER POSTS AND FACING DAMAGED BEYOND REPAIR BETWEEN STATIONS 222+62 TO 223+12. RECOMMEND REPLACEMENT OF THIS SECTION.

Replace the rockfall barrier between Stations 222+62 and 223+12. Given the poor condition of the barrier sections both ahead and back station of this area it is recommended that a new 70' long, 10' high barrier be constructed directly behind the existing barrier between Stations 222+52 and 223+22. This will serve to restore the functional catchment capacity to this area. In addition, the new barrier can be extended ahead and back station in the future should the PAAC decide to replace the existing barrier.

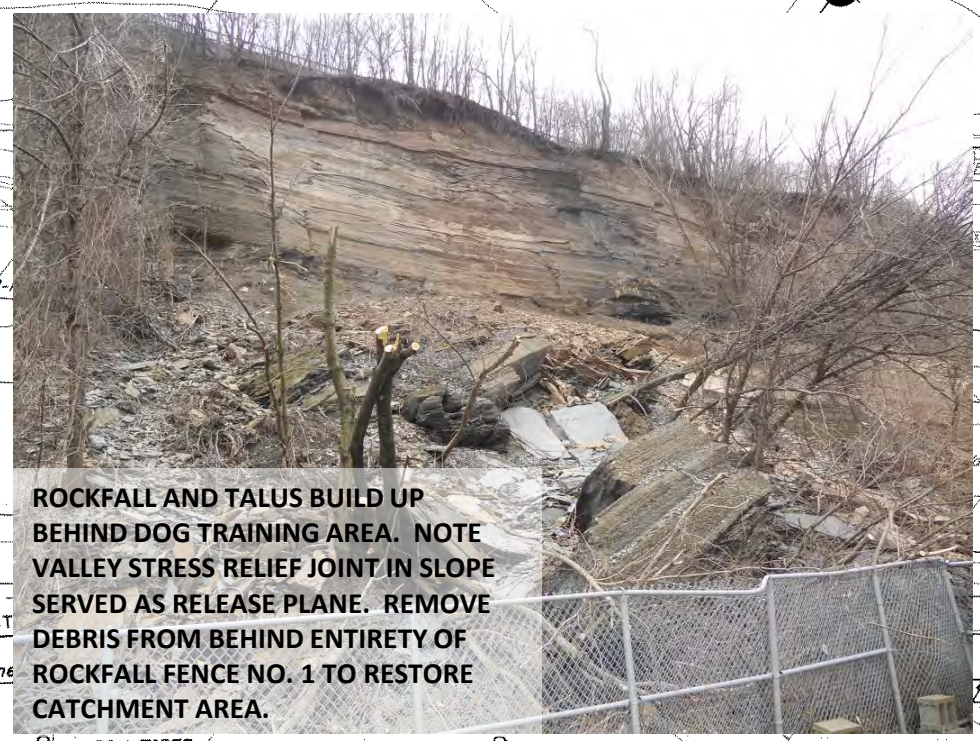
ROCKFALL AND TALUS BUILD UP BEHIND DOG TRAINING AREA. NOTE VALLEY STRESS RELIEF JOINT IN SLOPE SERVED AS RELEASE PLANE. REMOVE DEBRIS FROM BEHIND ENTIRETY OF ROCKFALL FENCE NO. 1 TO RESTORE CATCHMENT AREA.

Remove of debris from behind Rockfall Barriers 1 and 2. Removing the debris will create additional catchment volume behind the barriers. This will allow for future small rockfalls and talus to accumulate behind the existing barriers.

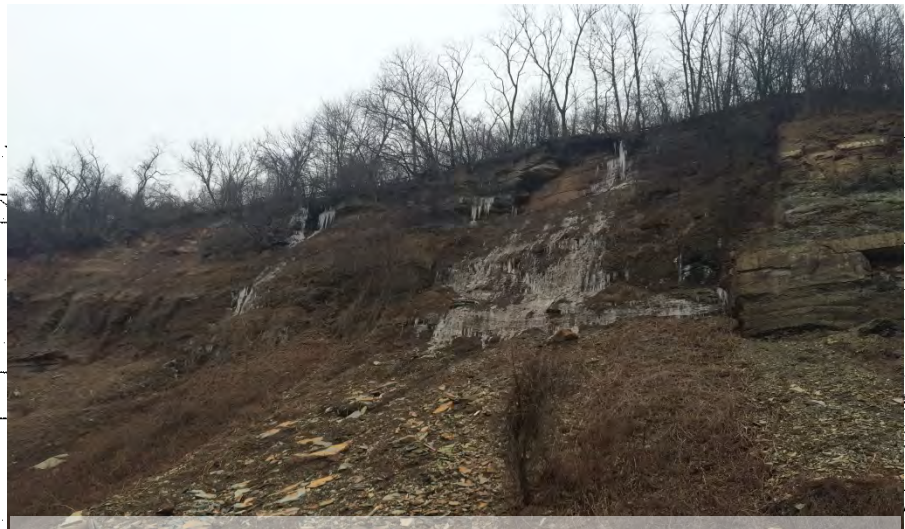
- Significant rockfall debris and talus have accumulated on the slope and within the catchment area between Stations 230+00 and 237+00. In general the debris has not impacted the busway, and is contained behind the guiderail. While the catchment area in this section is adequate to contain rockfall, the debris should be removed to allow for future rockfall material to accumulate.

ROCKFALL FROM TOP OF SLOPE. DEBRIS PATH EXTENDS TO EDGE OF BUSWAY. LARGE OVERHANGS POSE ADDITIONAL ROCKFALL THREAT TO BUSWAY. RECOMMEND REMOVAL OF ROCKFALL DEBRIS FROM CATCHMENT AREA BETWEEN STA. 230+00 AND 237+00.

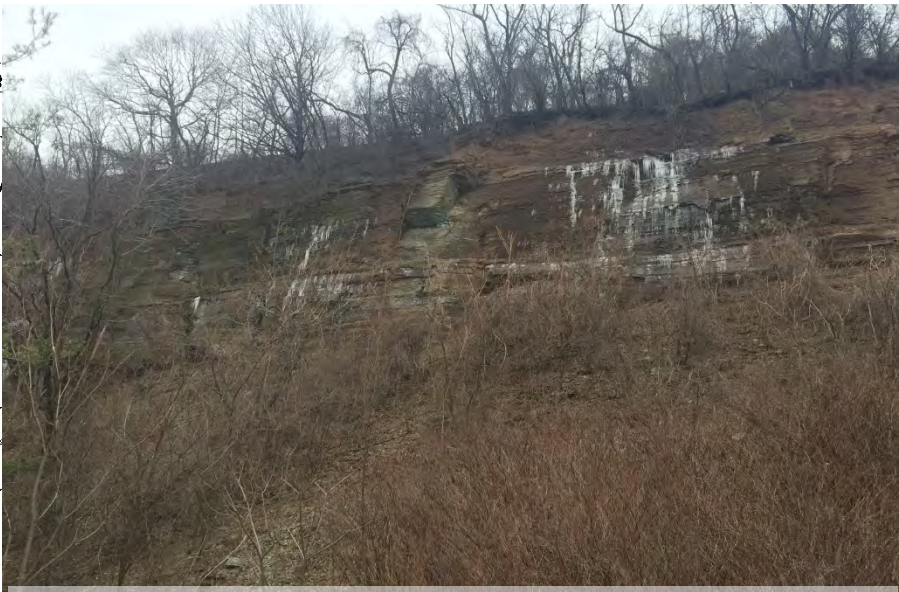
UNDERCUT ROCKBLOCK NEAR TOP OF SLOPE ILLUSTRATES VALLEY STRESS AND TECTONIC JOINT SETS.

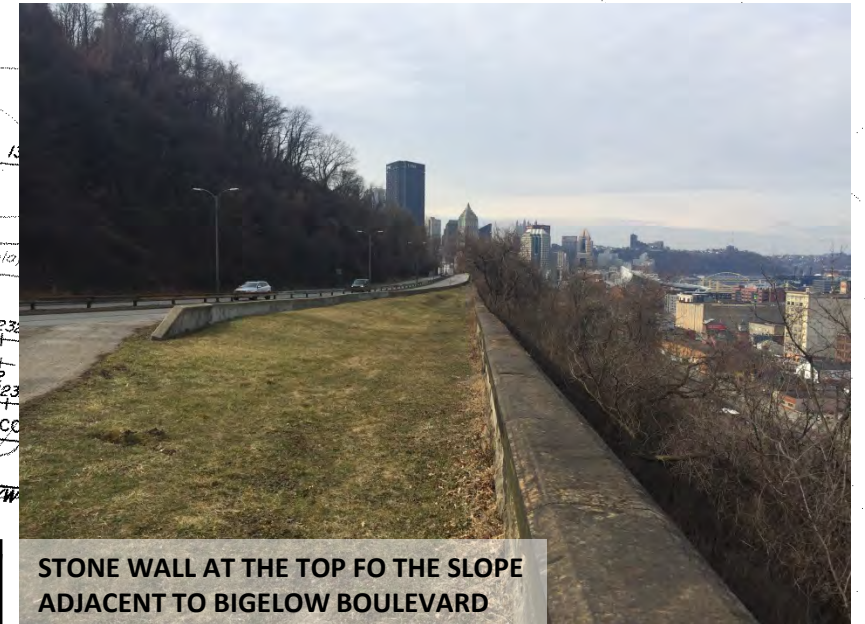
- The stone retaining wall that supports Bigelow Boulevard at the top of the slope appears to be in good condition, with no visible failures or distress.

STONE WALL AT THE TOP OF THE SLOPE ADJACENT TO BIGELOW BOULEVARD

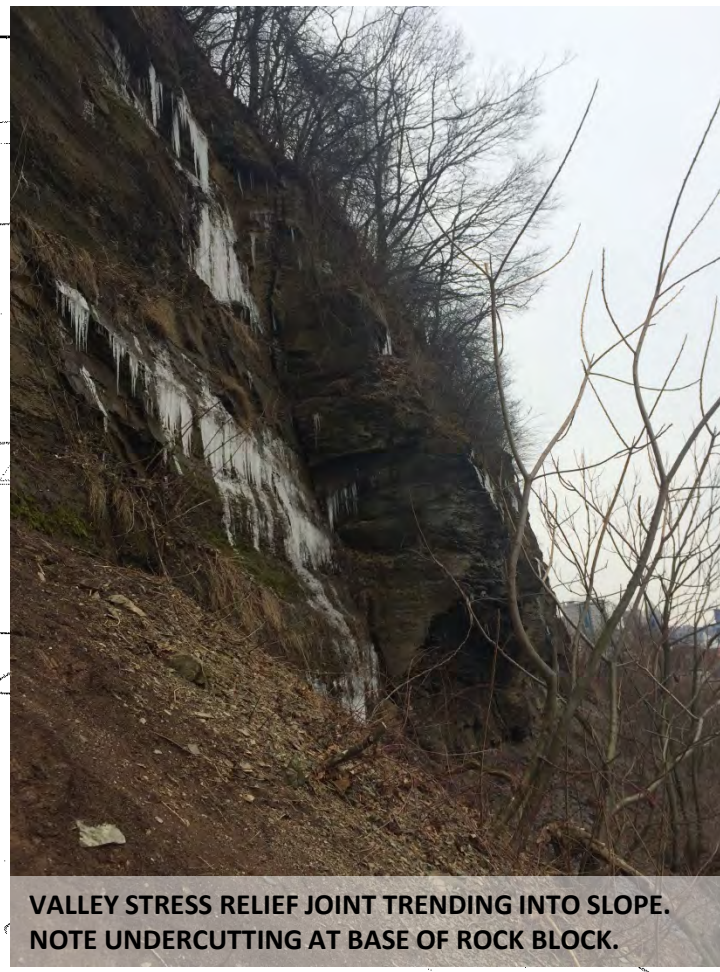
VALLEY STRESS RELIEF JOINT TRENDING INTO SLOPE. NOTE UNDERCUTTING AT BASE OF ROCK BLOCK.

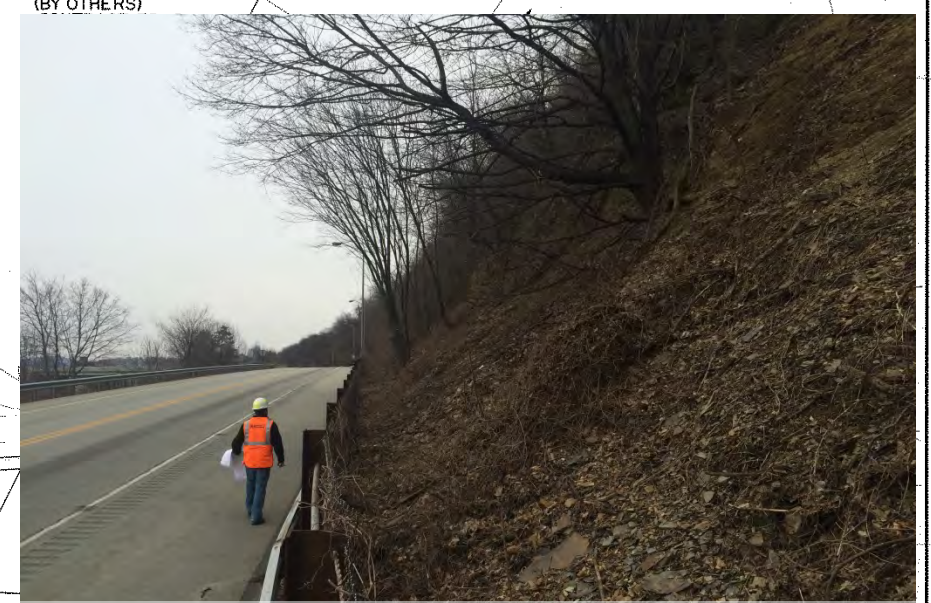
- Significant rockfall debris and talus have accumulated behind the rockfall barrier between Stations 238+00 and 247+00. The barrier posts, cables, and facing are in very poor condition with failures of the wire cables and connections throughout the length of the barrier. In addition to the barrier being functionally obsolete due to the condition of the barrier hardware, the barrier is not functioning as intended due to the accumulation of debris, eliminating the desired catchment volume. Removal of the debris from behind the barrier is necessary for the barrier to have any service capacity in the short term and complete replacement will be required for long term rockfall protection.

TALUS BUILD UP BEHIND ROCKFALL BARRIER. CATCHMENT AREA IS COMPLETELY FILLED AND BARRIER IS SERVING AS RETAINING WALL

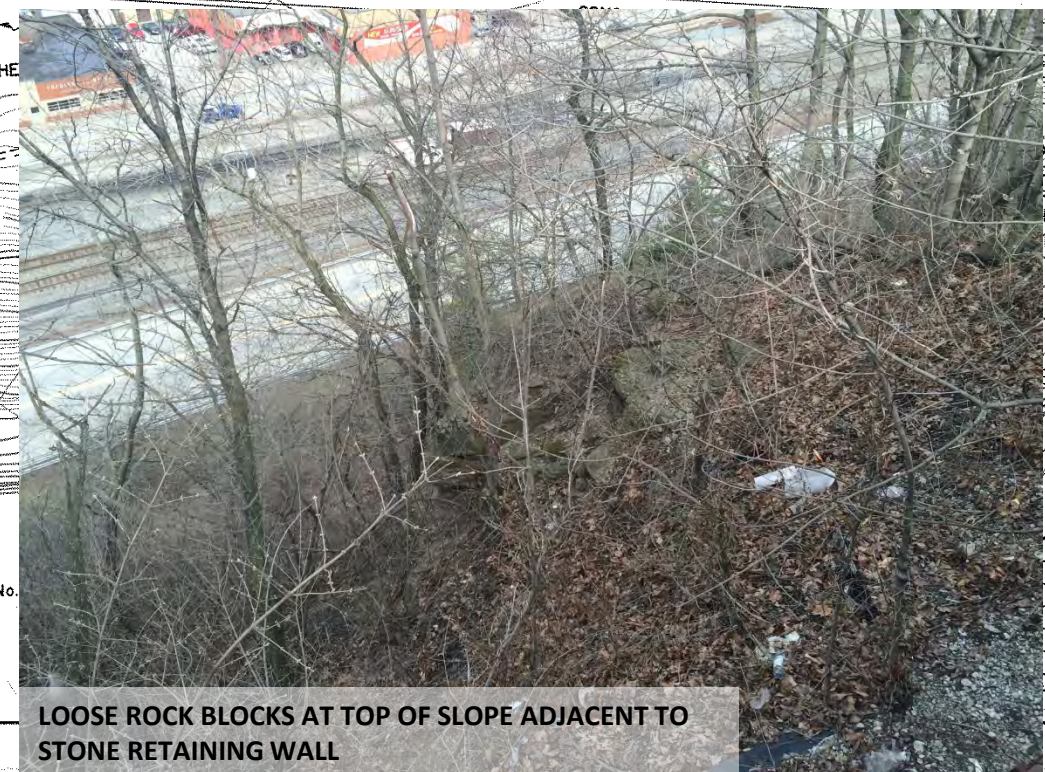
- Several large blocks of rock, which appear to be detached, are situated within the upper portion of the slope below Bigelow Boulevard. These blocks pose a potential rockfall threat to the Busway and should be removed as part of the mitigation program.

LOOSE ROCK BLOCKS AT TOP OF SLOPE ADJACENT TO STONE RETAINING WALL

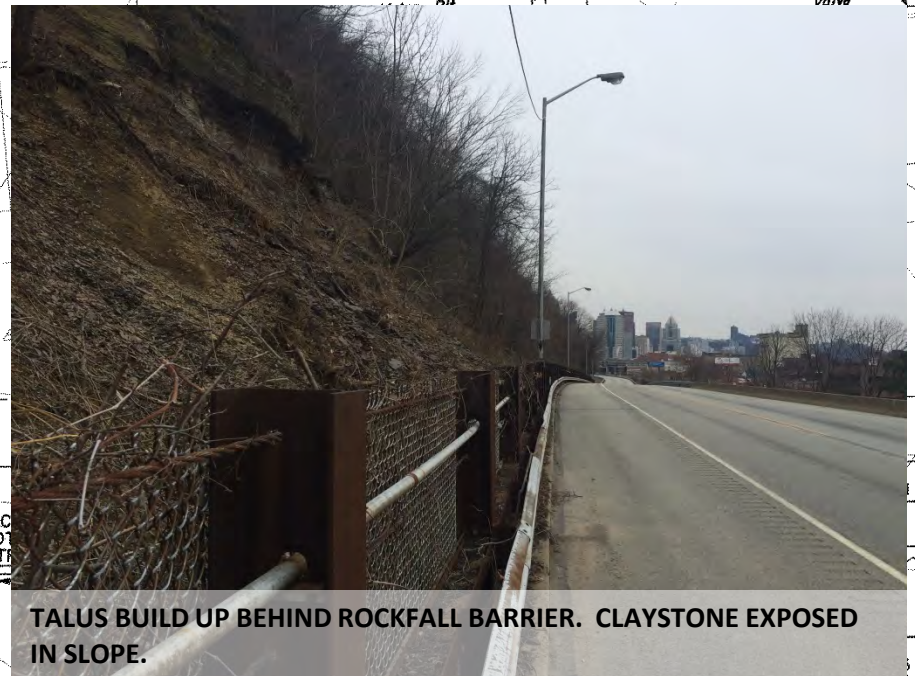
TALUS BUILD UP BEHIND ROCKFALL BARRIER. CLAYSTONE EXPOSED IN SLOPE.

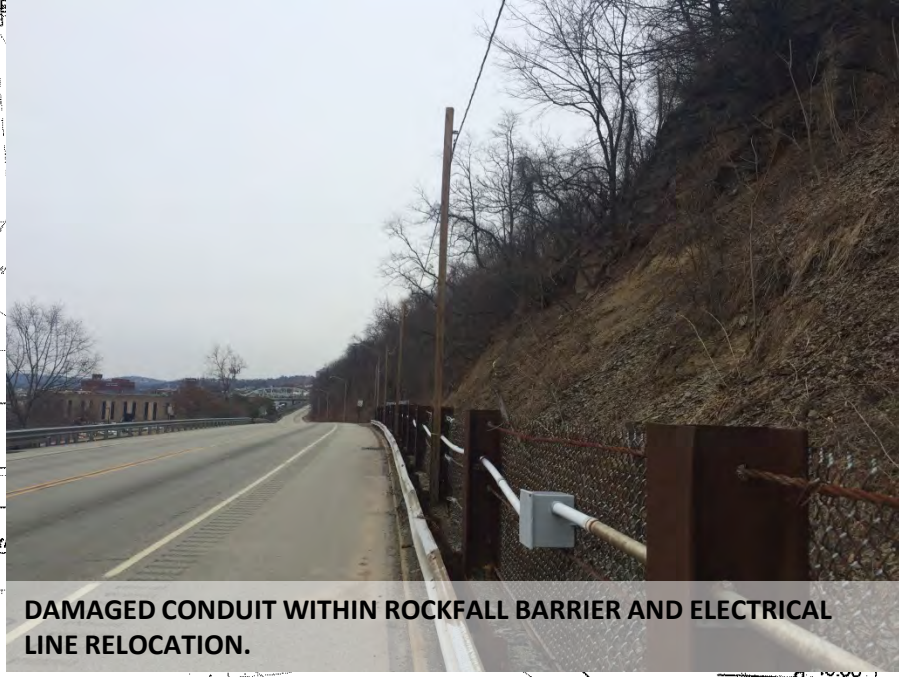
DAMAGED CONDUIT WITHIN ROCKFALL BARRIER AND ELECTRICAL LINE RELOCATION.

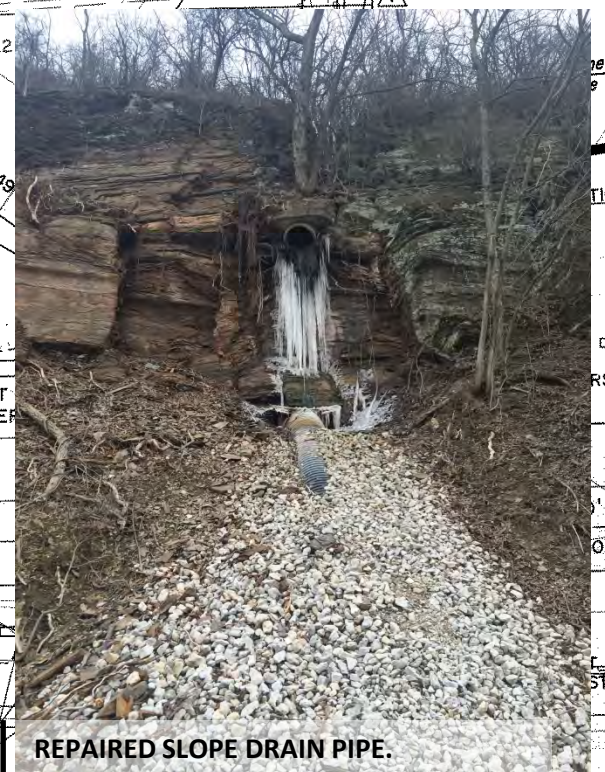
REPAIRED SLOPE DRAIN PIPE.

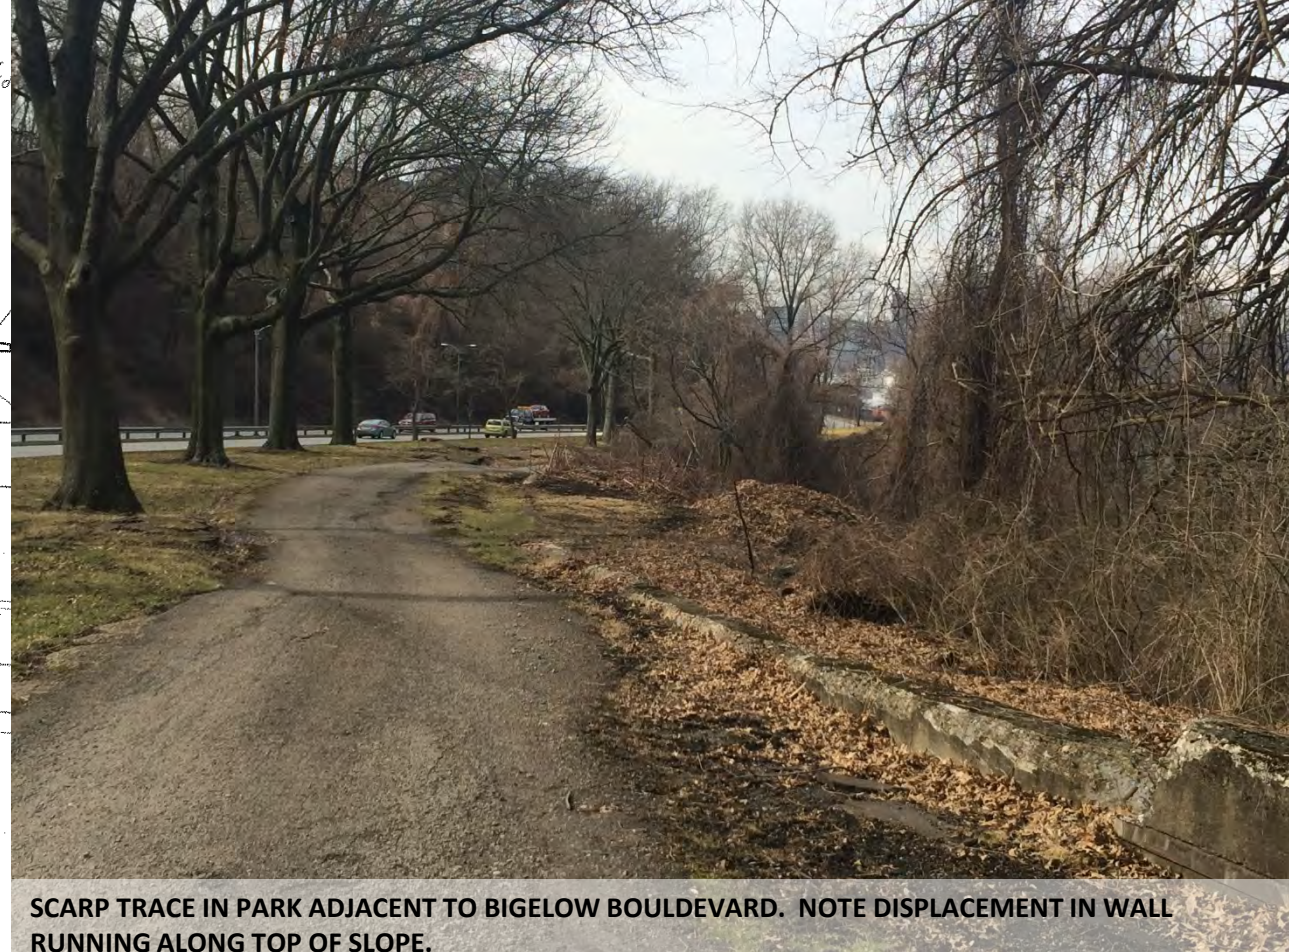
SCARP TRACE IN PARK ADJACENT TO BIGELOW BOULEVARD. NOTE DISPLACEMENT IN WALL RUNNING ALONG TOP OF SLOPE.

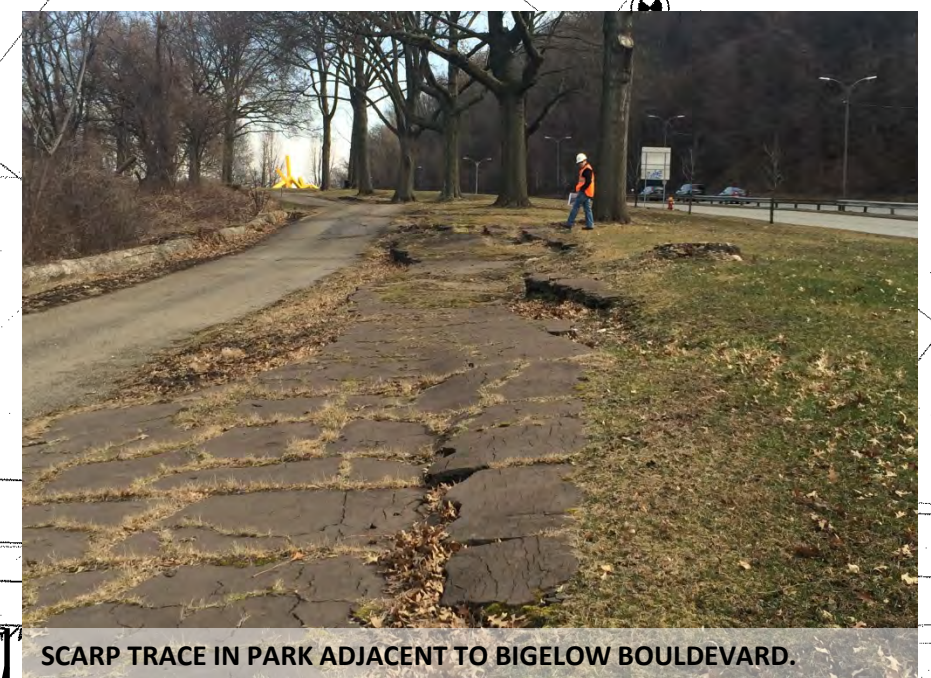
SCARP TRACE IN PARK ADJACENT TO BIGELOW BOULEVARD.
